SILTING OF THE SIELPIA WATER RESERVOIR IN THE 20TH AND 21ST C. (CENTRAL POLAND)

In the 20th and 21st c. the Sielpia water reservoir was silted several times. The reasons for this were the progressive bed erosion caused by the disappearance of the anthropogenic small-scale water retention system and repeated catastrophic discharges caused by dams destructions. At that time it came to the significant environmental changes.

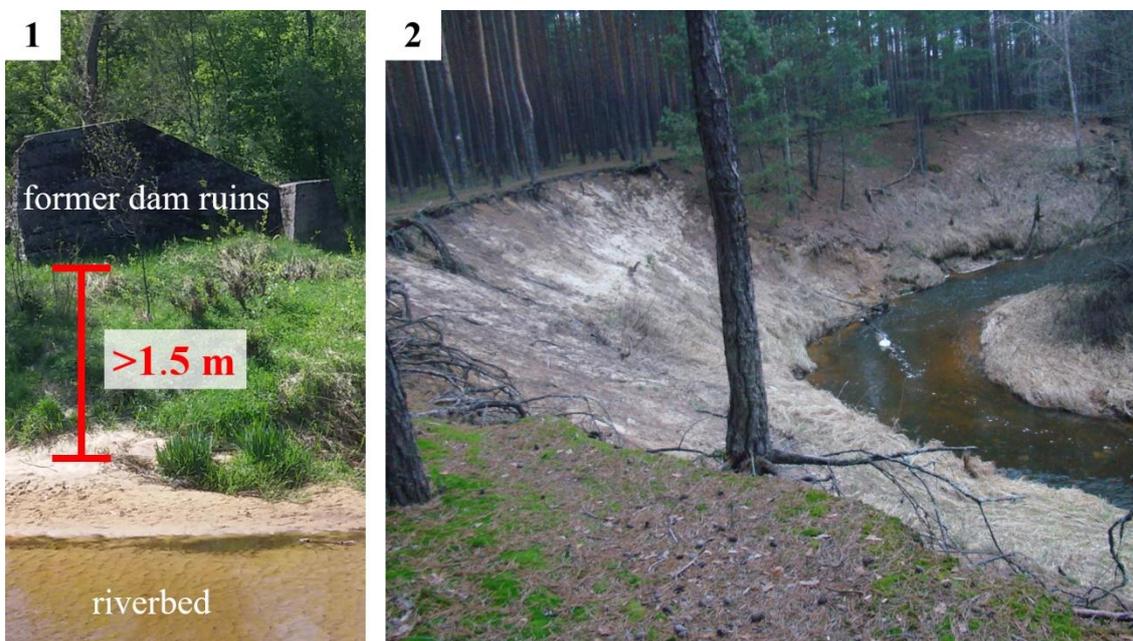
Figure 3. Effects of progressive erosion and catastrophic discharges in the riverbed
 1 - river level lowering relative to the ruins of the former dam at Małachów,
 2 - confined meanders downstream of Janów

The effects of progressive headward erosion and catastrophic discharges from the 2nd half of the 20th century were inventoried in the section of the Czarna Konecka valley floor downstream of Janów (Fig. 2): undercuts of river banks, an incision of the riverbed, confined meanders (Fig. 3), transformation of some floodplain section into a terrace, erosion forms on the floodplain, very coarse deposits of cut-and-fill and alluvial covers in the valley floor [6], [7], [8]. They document the disappearance of a significant part of the sediments in the riverbed zone. The river probably transported the missing deposits to the estuary section (downstream of Piekło village) and to the pond at Sielpia (Fig. 2). This is indicated by bathymetric measurement results, which show that near river mouth into the reservoir depth of lake usually doesn't exceed 50 cm and there are shallows (Fig. 4). An inland delta was created there [7], [8], consist of sandy material, which is also in river bank undercuts profiles upstream of Sielpia.

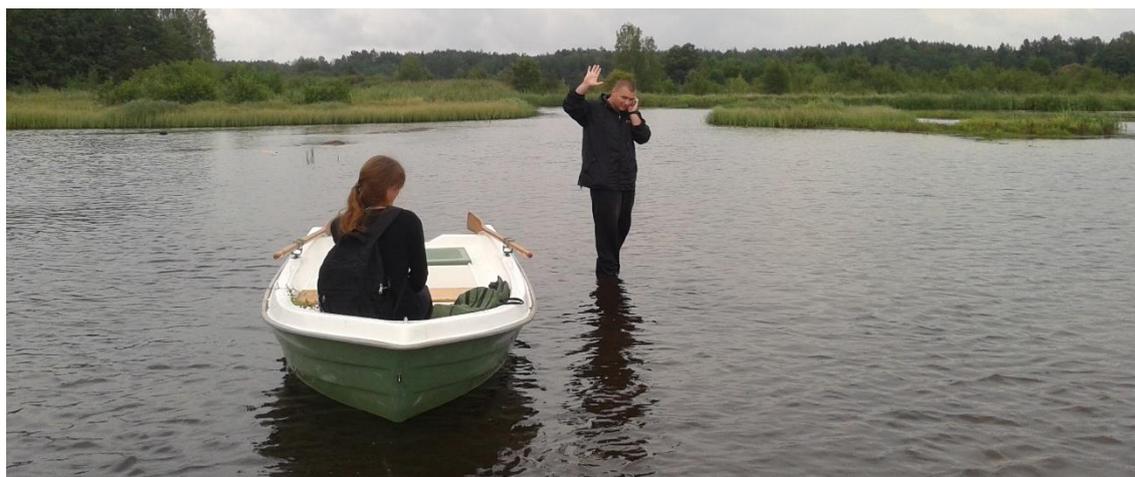
Figure 4. Shallow of the reservoir near the river mouth and the grain size and Folk-Ward's distribution parameters of the top sediments of the inland delta

The Sielpia water reservoir (55 ha) is located on the Czarna Konecka river (central Poland), which drainage the north-western margin of the Holy Cross Mountains (Fig. 1). It was constructed at the beginning of the 19th century and for about 100 years it was used as an industrial pond of the metallurgical plant [1]. In the 30s of 20th c., the dyke dividing the pond has been destroyed during floods¹. This destruction may have been due to the neglect of the hydrotechnical infrastructure after the collapse of the local ironworks in 1921 and the progressive silting of the reservoir (water overflow due to reduction of the pond capacity). The disappearance of the anthropogenic small-scale water retention system (small ponds) on the river near Piekło village [2], [3] between 1915 and 1938 [4] may have been conducive to the process of silting of Sielpia water reservoir at that time. The Sielpia water reservoir was rebuilt in the 60s of 20th c. Since that time, it has been silting again as a result of e.g. anthropogenic flash floods caused by breakdowns of dams (Fig. 2) on Czarna Konecka river [5], [6], [7], [8]. In the 80s, part of the muds from the bottom of the pond were replaced by sand (maintenance works)¹. Obtained ecological condition of reservoir did not last long, because its silting was progressed. Due to the unrepaired dam in Małachów (destruction in 1993) an increase of bank and bed erosion (Fig. 3), rate and size of bedload transport in the river and accumulation in the pond occurred [9]. As a result of these processes, the area and capacity of the Sielpia water reservoir has decreased [8], [10] and it is very shallow (Fig. 4).
