## THE VULNERABILITY OF THE SACRAL LANDSCAPES IN BUKOVINA

**Divisevici Ana Maria<sup>1</sup>**

<sup>1</sup> Stefan Cel Mare University, Faculty of History and Geography, Suceava, **Romania**

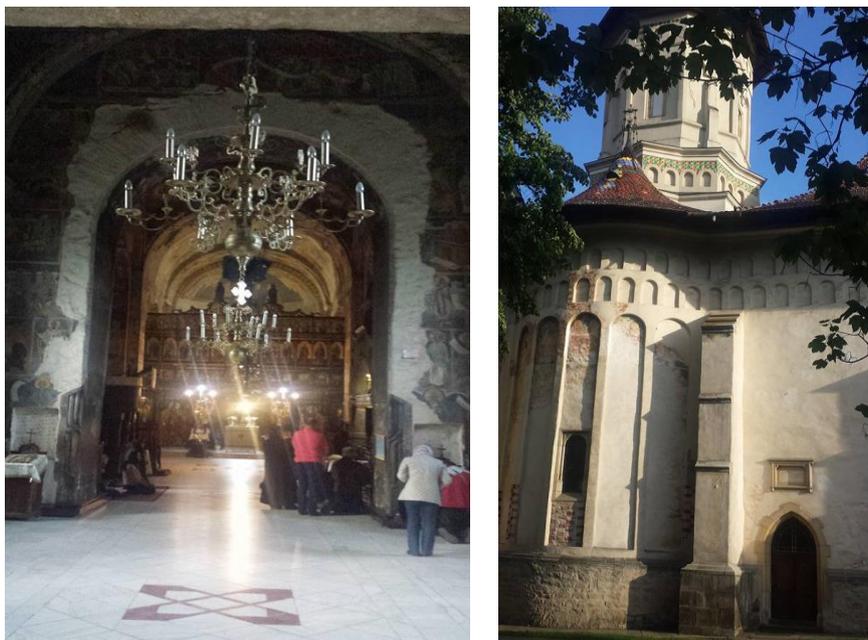
**Figure 2.** St. George Church- the nave and the North façade  
Photo by author

The scratches and incisions over the a fresco painting inside the churches of St.George in Suceava [fig.2] and Arbore which are very common, were first made by the monks, then by the parishioners, the invaders, the tourists or the evil intentioned persons.[8]

In the case of St. Gheorghe in the nave, in the south part the damaged engravings are visible even after numerous attempts of restoration. A conclusive example of the destructive effect is the extended surface incisions and scriptures over the fresco over the stage of *The Baldachin Offering* made by the Polish soldiers. Other incisions mentioned the year in which the holly relics were grabbed in 1686, but also the year of their return, 1783

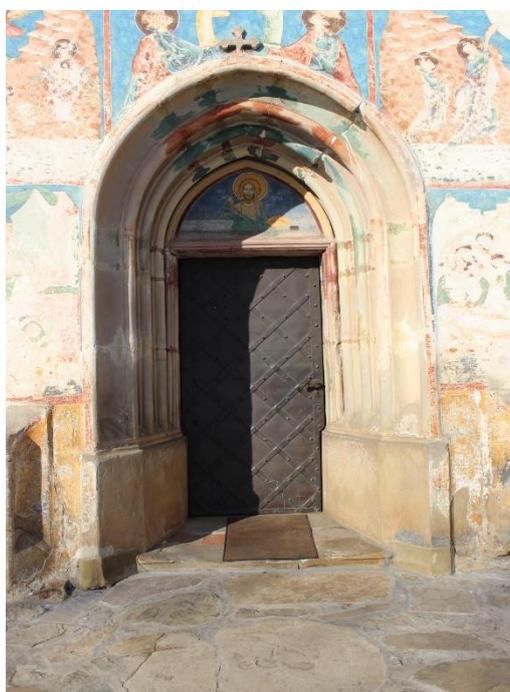
**Figure 3.** Arbore Church- above the main entrance in Gothic style, there is the icon of St. John the Baptist nowadays in the stage of re-restoration  
Photo by author

The Arbore Church was repainted several times in the last 500 years, in 1845, 1887 and 1980 for the purpose of covering the traces of vandalism. The restoration made by Ion Bodnarescu in 1887 through personal additions and re-interpretations produced a diminuation of the Byzantine stylistic value and the irreversible destruction of some painted scenes. The icon placed in the upper part of the exonartex entrance of the spiritual patron of the church, St. John the Baptist was repainted in 1845.[Fig.3] The new image

received the influences of the neorealistic style, characteristic of that period, the original painting unfortunately was not understood and appreciated being completely over covered, but through the meticulous work of restorers the original image could be recovered.

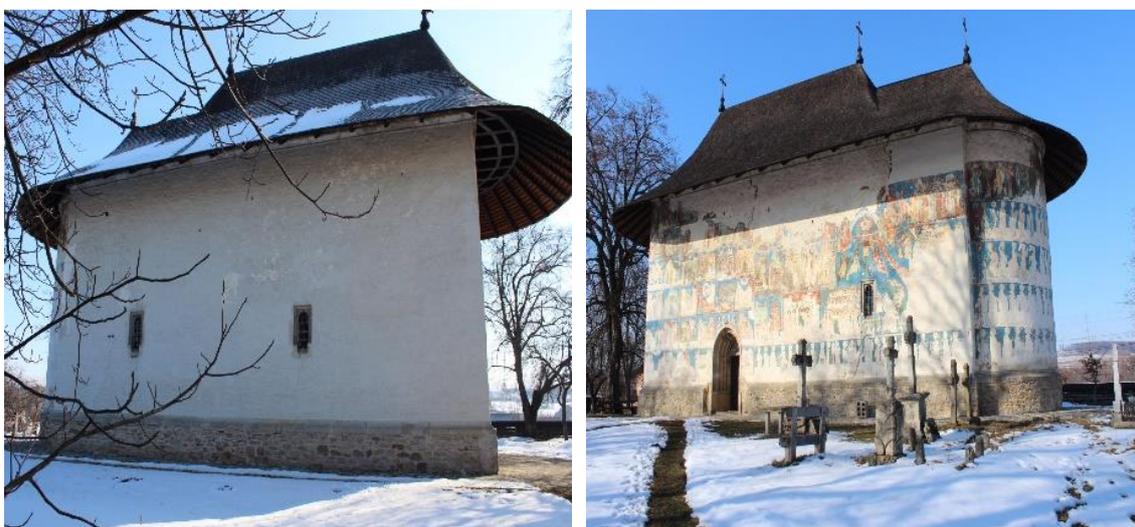
**Figure 4.** the northern and southern facade of Arbore Church  
Photo by author

At the Church of Arbore village [fig.4], the roof degradation was favoured by a series of convergent forms of destruction, which eventually led to the irreversible alteration of the color layer and to the over 60% total loss of exterior mural painting. The northern facade is completely erased due to structural deterioration, masonry cracks, defective pluvial collection system and the very high humidity in the immediate vicinity that favoured infiltration. An equivalent process took place to the northern face of St. George's church in Suceava.

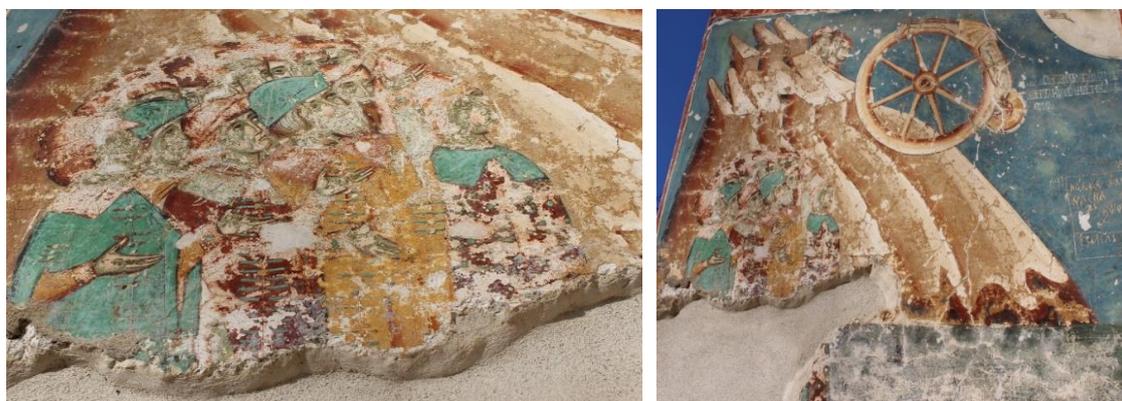
**Figure 5** Arbore Church -Detail from the Western façade. Even if it is in an advanced stage of decay, the murals express the extraordinary technical mastery of the painters  
Photo by the author

Poor restorations have contributed to the acceleration of the degradation process, requiring careful interventions by specialists, reconstruction of the painting layers, restoration of pigments from original colours or consolidation of the church walls. [Fig5] After the end of the restoration interventions which started in 1980, as an emergency restoration initiative, both churches underwent many other stages. The restoration program ended right after 2004, when the unique elements of great value and originality were reinstated that previously had been hidden to the viewer. [9]
