**VULNERABILITY OF CULTURAL HERITAGE TO  
ANTHROPOGENIC IMPACTS: A CASE STUDY OF THE  
STEĆCI NECROPOLIS IN THE CITY OF EAST SARAJEVO**

**ABSTRACT**

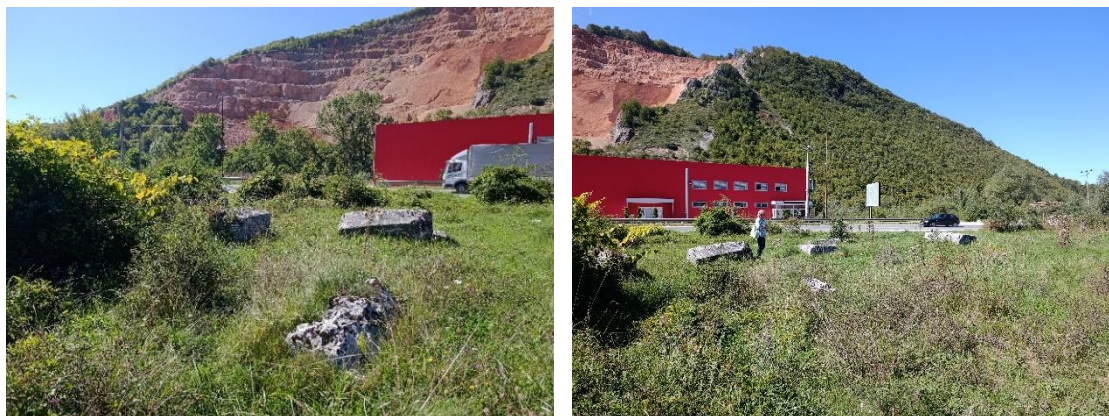
**Figure 2.** The Krupac necropolis (photo LukićTanović M.)

The settlement of Krupac in the municipality of East Ilidža is located in the southeastern part of the Sarajevsko polje, at the point where the Željeznica River emerges from a canyon. The necropolis of stećci is situated next to the Sarajevo–Trnovo main road (Figure 2). The present-day site is not the original location of the necropolis, as it was relocated from its initial site, Kovačevina, due to the opening of a quarry. The original necropolis in Krupac was mentioned by Đuro Basler in 1951, when he recorded 37 stećci [17]. Bešliagić mentions a necropolis with 33 stećci at the Kovačevina site in Krupac; these were undecorated and located next to a modern Orthodox cemetery [18]. In the immediate vicinity of the necropolis there was also an old Muslim cemetery. Until 1977, the entire complex of stećci was located on the western side of the Sarajevo–Trnovo road. This cultural and historical site was threatened by quarrying activities, which continuously expanded toward the necropolis, so that by 1976 the necropolis was located at the edge of a precipice 10–15 m deep [17]. In 1977, the necropolis consisting of 23 stećci and 14 nišans was relocated to a new site on the eastern side of the Sarajevo–Trnovo road, where it remains today. The relocation was carried out by experts from the City Institute for the Protection of Cultural Monuments in Sarajevo.

This necropolis, under the name “Historic Area – Necropolis with Stećci and Nišans in Krupac”, was proclaimed a National Monument of Bosnia and Herzegovina in 2007. The national monument consists of 21 stećci and 12 nišans. A site inspection conducted in 2007 established that the site was not being maintained, that some monuments had cracked due to natural factors, and that traces of repairs were visible on several nišans [17].

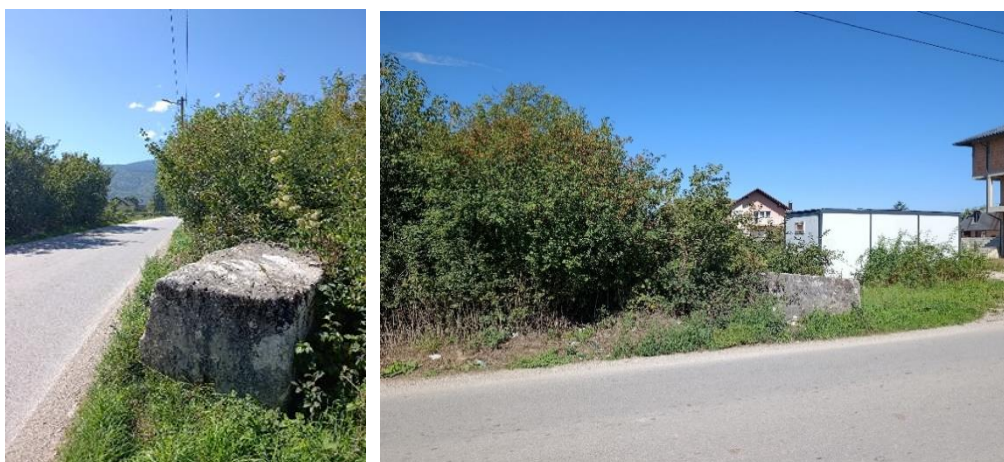
**Figure 3.** The Crnač-Donji Kotorac necropolis (photo Golijanin J.)

The Crnač necropolis is located in the settlement of Donji Kotorac in the municipality of East Ilidža, at a site approximately 100 m from the Sarajevo–Trnovo road. A local road cuts through this necropolis (Figure 3). According to Bešlagić, a necropolis with 59 stećci is situated at the Crnač site, in the immediate vicinity of the former airport on the Butmirsko polje [18]. The monuments are mostly of large dimensions, well carved, but damaged and partly sunken into the ground. [18].

A site inspection conducted in 2012 established that the necropolis area was overgrown with low vegetation, thorny bushes, and grass, and that some of the stećci were partially or completely sunken into the ground. Based on the configuration of the terrain, it can be assumed that their number may be greater. The stećci are exposed to accelerated deterioration due to the lack of regular maintenance. Plant organisms (lichens and moss) are present on the monuments and contribute to the deterioration of the stone structure, while the sunken stećci could not be technically documented. The decision also identifies specific risks, such as the disintegration of the site due to long-term neglect, adverse atmospheric influences, and the spread of spontaneous vegetation [19].

When it comes to the protection of necropolises that have been proclaimed national monuments of Bosnia and Herzegovina, the Government of Republika Srpska is obliged to ensure legal, scientific, technical, administrative, and financial measures for the research, protection, conservation, and presentation of the national monument [17], [19]. At the same time, the Commission to Preserve National Monuments of Bosnia and Herzegovina is responsible for determining the conditions and providing funds for the preparation and installation of an information board containing the basic information about the monument and the decision proclaiming the property a national monument [17], [19].

For the purpose of the permanent protection of the national monument, Level I and Level II protection regimes have been established. Within the Level I protection regime, the prescribed measures include: the prohibition of any construction activities; the enclosure of the national monument with a hedge; the clearing of the parcel of self-grown vegetation; the undertaking of archaeological investigations of the graves; and the implementation of conservation works on any human remains that may be discovered. Furthermore, it is necessary to ensure the preparation and implementation of a programme for the presentation of the national monument. The monument area should remain open and accessible to the public and may be used for educational and cultural purposes. The Level II protection regime applies to the area within a radius of 50 m around the necropolis. Within this zone, it is prohibited to carry out activities that could alter the area or change its ambient character, and the disposal of waste is not permitted [17].

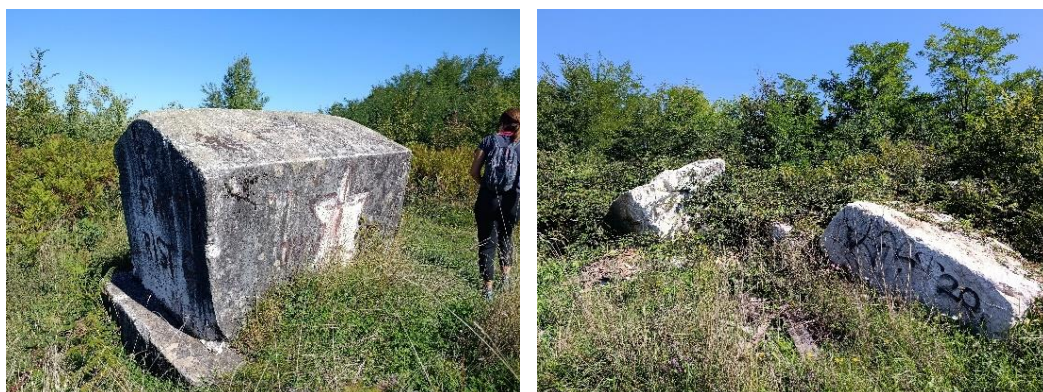
**Figure 4.** The Pavlovac necropolis (photo Lukić Tanović M.)

The Pavlovac necropolis is located in the municipality of East Ilidža, on Pavlovac Hill in Kasindo, and represents an example of an urban necropolis that has been almost completely destroyed due to human negligence (Figure 4). The site once contained a necropolis with 28 stećci (22 chest-shaped and 6 gabled monuments) and the monuments were very well carved, although they were damaged, partially sunken into the ground, and overgrown with forest. [18].

The destruction of the necropolis began in 1980, when it was relocated by the Yugoslav People's Army for the purpose of constructing a military training ground. One part of the stećci was moved to the site of Donje Mladice, while another part was relocated to Krupac. Only the largest stećak, believed to belong to Pavle Radenović, remained at the original site, most likely because its weight made relocation impossible. This stećak has a volume of 11.40 m<sup>3</sup> and a weight of 31,920 kg, making it the largest known stećak [18]. The relocation of the stećci was carried out under professional supervision, specifically under the supervision of the then City Institute for the Protection and Use of Cultural-Historical and Natural Heritage. However, the irresponsible attitude toward the relocated stećci, both by the local population and by municipal and city authorities, led to their almost complete destruction. The stećci that had been placed at the secondary site of Donje Mladice were further damaged during the construction of a hotel at that location, after which they were returned to the original site, where they remain today in very poor condition. The results of the analysis of anthropogenic impacts on the three aforementioned necropolises are presented in Table 2.
