**HYDROMORPHOLOGICAL STATE AND HABITAT QUALITY OF  
MOUNTAIN RIVERS ABOVE AND BELOW RESERVOIRS  
(THE POLISH CARPATHIANS)**

**Dr. Malgorzata Kijowska-Strugala**

**Dr. Łukasz Wiejaczka**

Polish Academy of Sciences, Institute of Geography and Spatial Organization, **Poland**

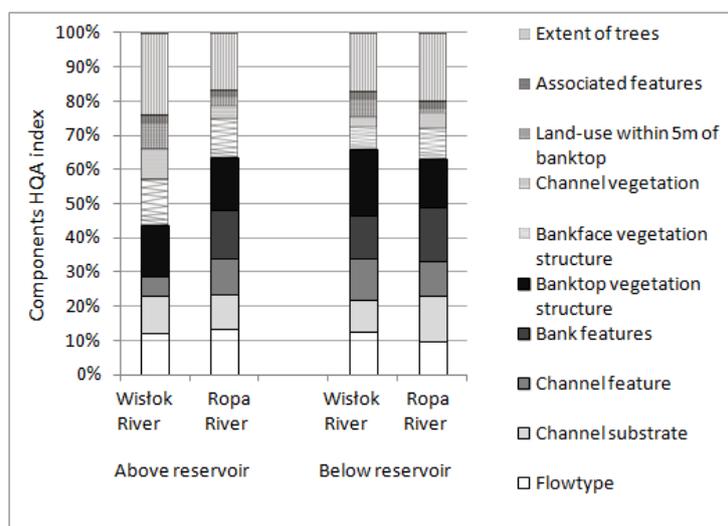
Figure 2. Components of Habitat Quality Assessment of analysed Wisłok and Ropa rivers above and below reservoir

Based on the investigation carried out, the HQA score was calculated, which is a synthetic sum total of the numerical values of elements in the natural environment. These elements affect the value of the HQA score to a varying degree (Fig. 2). Consideration of only the natural morphological elements of the channel and banks implied reduced significance of these elements for the overall value of the HQA index, especially in the case of the investigated sections of the Wisłok river above the Besko reservoir (Fig. 2). In the case of the Ropa river, the share of these morphological elements in the value of the HQA index amounted to 25% above the reservoir and 26% below it. It should be noted, however, that both in the case of the Wisłok and the Ropa rivers, above the reservoir there was noted an increase of the percentage share of the natural elements of the riverbank in the overall value of the HQA index with regard to the sections located below the reservoirs. A very important element for the assessment of the naturalness of the watercourse is the bankface and banktop vegetation. For both rivers, it has a high share in the value of the HQA index, with a higher percentage share recorded along the river sections above both of the reservoirs than below them (Fig. 2). A significant role in the RHS method is also played by tree coverages and the accompanying morphological elements. In the case of both rivers, a high share of these elements in the increase of the naturalness index of the river was caused by the presence of especially tree coverages (from 17% – the Ropa river above the reservoir to 24% – the Wisłok river above the reservoir), which are valuable for the environment from the perspective of the RHS method.

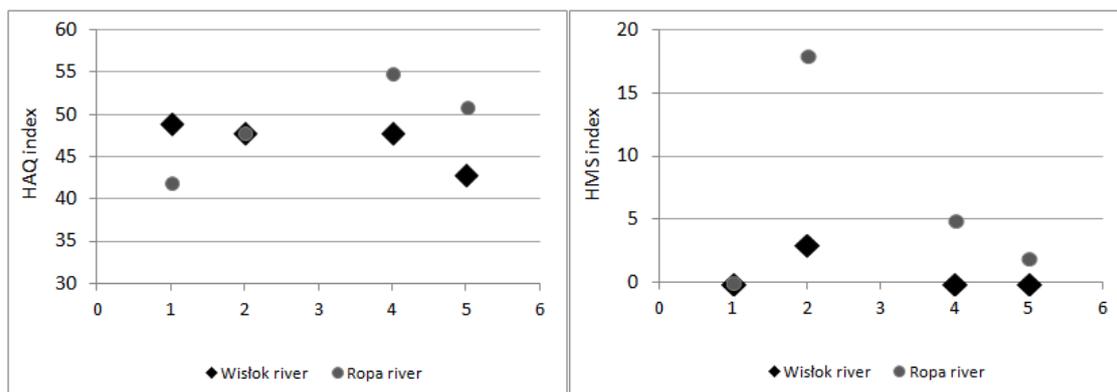
**Figure 3.** Changes in HQA and HMS index along the Wisłok and Ropa rivers channel course on 2 section above and 2 section below reservoirs (1 - 1st section above reservoir; 2 - 2nd section above reservoir, closer to the reservoir; 3 - 3rd section below reservoir, closer to the dam; 4 - 4th section below reservoir)

The sections of both rivers that were located within the Besko and Klimkówka reservoirs were characterised by high values of the HQA index that is measure of the naturalness of a river. In the case of the Ropa river, these values fell within the range of 48-51, and for the Wisłok river in a lower range of 43-49 (Fig. 3). The greatest diversification of the

HQA index value is associated with the Ropa river. Lower values were calculated for the river sections located above the Klimkówka reservoir in relation to the sections below the reservoir. This results from a larger number and diversification of the natural morphological elements within the channel (vegetated mid-channel bars, unvegetated point bar) and the surroundings of the river below the Klimkówka reservoir. A reversed situation was observed in the case of the Wisłok river (Fig. 3).

The HMS index values that define the degree of anthropogenic changes in the river hydromorphology were in the range 0-18 for the Ropa river and for Wisłok river were in a narrower and lower range of 0-3 (Fig. 3). It was established that the higher degree of transformation was characteristic for the sections located closest to the reservoirs (with the exception of the Wisłok river below the Besko reservoir where the HMS index value amounted to 0), (Fig. 3). Significantly higher values of the HMS index on the Ropa river as compared with the Wisłok river resulted from the presence of bank reinforcements and the resectioned of the banks for river engineering purposes. Additionally, they were influenced by the presence of a river crossing and a bridge. According to the classification by [7] (as modified by [8]) concerning the HMS index, the investigation sections above (mean HMS value = 2) and below (mean HMS value = 0) the Besko reservoir were classified as natural habitat. The investigation sections above the Klimkówka reservoir can be classified as little changed (mean HMS value = 9) and the ones below as slightly changed (mean HMS value = 4) (Table 2).
