ALTERATION OF THE MORPHO-HYDROLOGICAL CONDITIONS OF THE AQUATIC COMPLEXES ADJACENT TO THE SF. GHEORGHE BRANCH (DANUBE DELTA) AS A RESULT OF THE HYDROTECHNICAL WORKS

Keywords: Danube Delta, wetlands, geomatics, underwater morphology

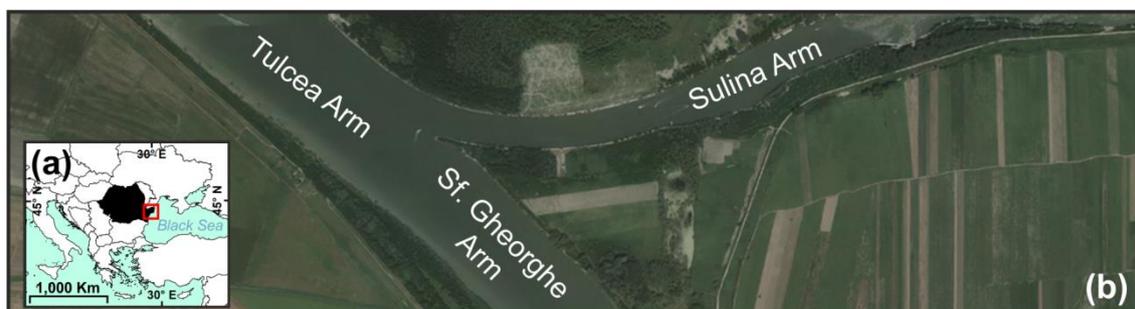
Figure 1. a. Location of the Danube Delta (SE Romania); b. The Sf. Gheorghe bifurcation

[30]. To start with, there is a need to know how much water the Sf. Gheorghe arm takes from the Tulcea arm. Various measurements were done before by different scientists and the variations between the measurements are dependent of the water level regime and this measurement was done at the average water level quota. The flow distribution situation is very interesting now: Sulina 40% and Sf. Gheorghe 60%. The bifurcation is presented in the Figure 1. and represents the starting point of the studied riverbed: St. Gheorghe.

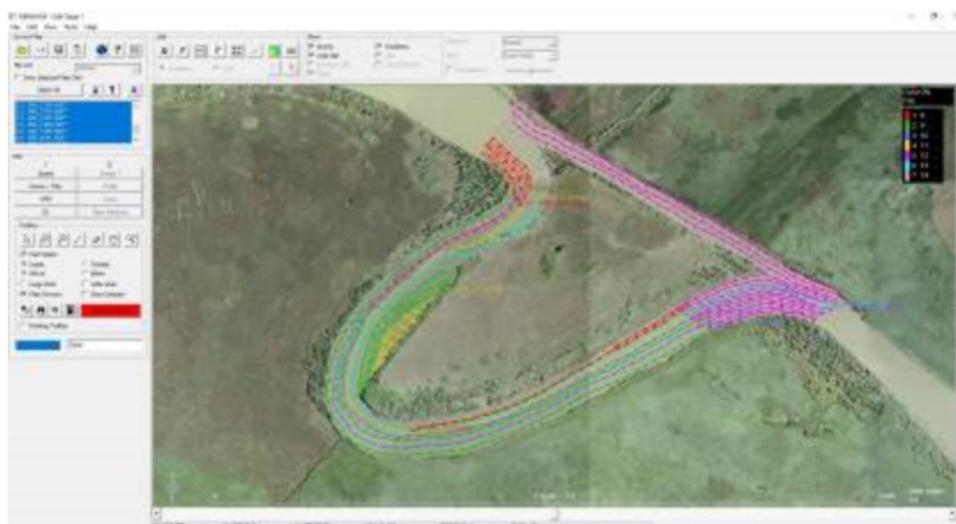
Figure 3. Boat routes for covering the whole survey area

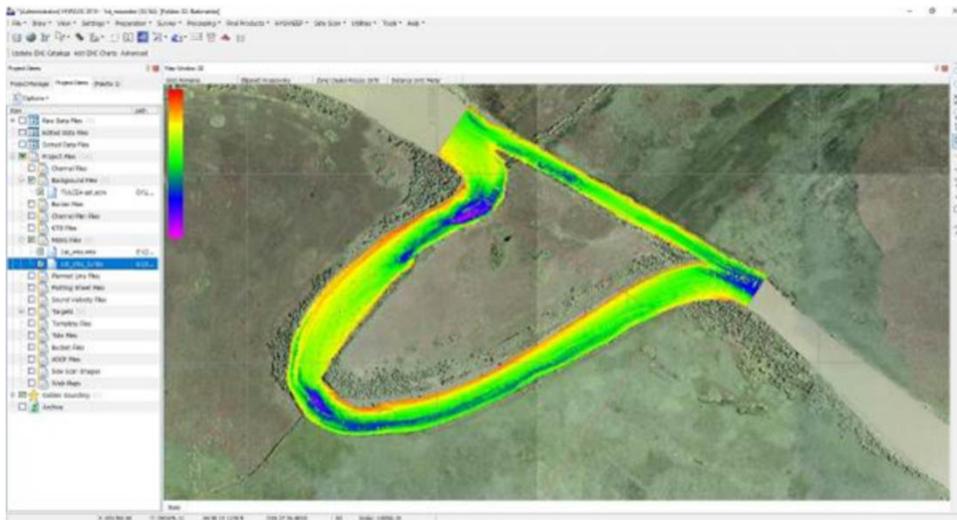
Figure 5. Matrix of raw bathymetric data collection

All these sensors are integrated into a RTA console (Real Time Applience) that transmits the data through UTP (Unshielded Twisted Pair) connection to a computer that runs ES3 together with Hypack software, where all this data is integrated and carefully calibrated. As soon as the equipment was installed on the survey boat, calibrated and checked, the survey started and the mapping routing paths of the Ivancea meander can be seen in Figure 3. The Figure 4 is displaying the data acquisition process, where the surveyor can monitor all the aspects of the measurement such as boat direction, soundings cover, the aspect of the profile, the different messages of the system, etc. This facilitates the data collection process to be as accurate as possible. As a result of the completion of the bathymetric data collection campaign, the general picture of the Ivancea meander riverbed aspect is shown in the final matrix (Fig. 5).

At first glance, a typical characteristic of meandering morphology is observed on the color palette. The river bed scours occur at a range of scales and settings and are most pronounced at river bends and channel confluences. The depths are surprisingly high

considering the low hydraulic slope and the proximity (~ 10 Km) of the mouth of arm into the Black Sea. However, the erosion processes are strong in the upstream part of the meander, where it erodes in the left bank of the island created by the hydraulic regulation, thus generating very high currents and depths (-24 m). But this is normal and to be expected for such natural processes. Further downstream on the meander, there is a submerged island in the convex part of the meander (close to the right bank) that acts as a barrier, thus protecting the former depths of the main course behind it, and also behaving as a precursor to the visible fairway that almost extends downstream, to the confluence with the main flow of the arm. The average depths are -12 m, in the upstream area where the erosion is strong in the meander, the depth is -24 m, the fairway that starts from the middle of the meander towards downstream has an average depth of -15 m, and downstream, at the confluence, where both discharges are rejoined, there is a deepening of the fairway that reaches up to -19 m.

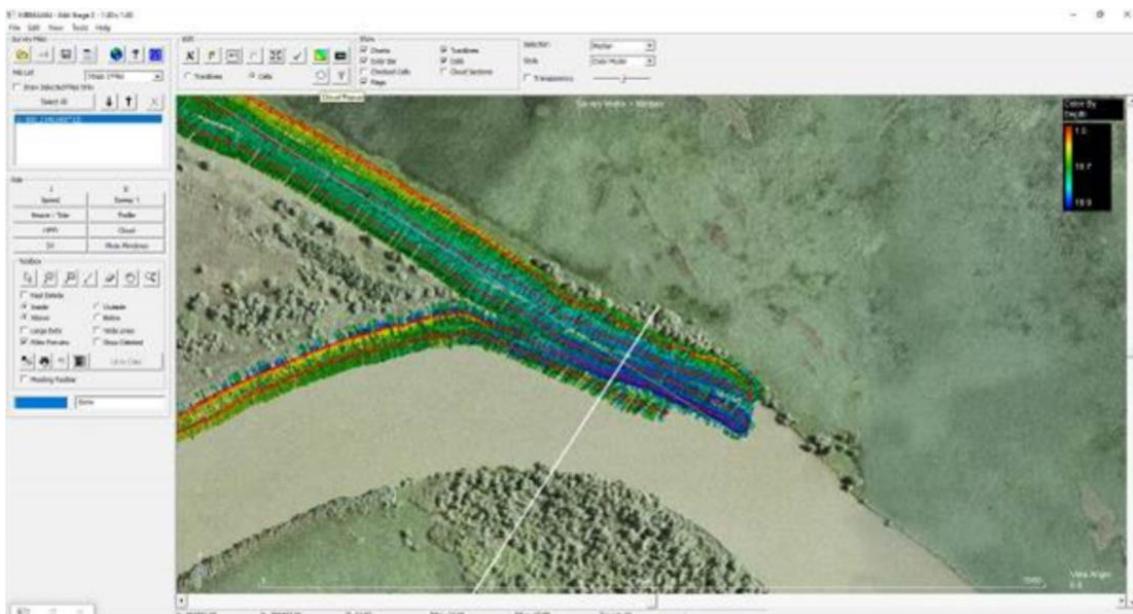
Figure 6. The sample location of the bathymetric data – downstream of the main course confluence with the meander

Data processing is done with in Hypack software package. This is modular software that allows to be used concurrently with other analysis processes. The MBMax module is used to process multibeam bathymetric data, allowing editing of collected points in the field by editing the anomalies, etc. The data can be viewed and edited as color-coded

wireframe, dots, mesh and variable number of soundings (depending on the computational resources). Some examples can be seen in Figures 6, 7 and 8.

The anomalies can be observed the in the collected data, namely those lines that rise or fall abruptly. These are referred in the literature as "spikes" and are usual abnormalities in any bathymetric data collection process. These occur due to a misinterpretation of the transducer induced by many variables: boat shocks due to engine speed, high velocity changes in water, suspended particle matter, fish banks, positioning error (changing the horizon of a one or more satellites), loss of TRK communication with the base GPS, etc. These abnormalities can be erased to a limited extent automatically by applying a depth filter and to a large extent manually. The software allows the user to view cloud points in multiple ways so that editing this data is as easy as possible. The data processing is a very meticulous task with trial and error methodologies, and the results are expert judgment
